Some new findings about the AVO CT160A! Revision E5, 16 Feb 11

With help from my friend Mr. Yutaka Matsuzaka, who has photographed the insides of two AVO CT160A's, and who has also measured the components values and traced some of the wiring, I have some new information to report on the CT160A.

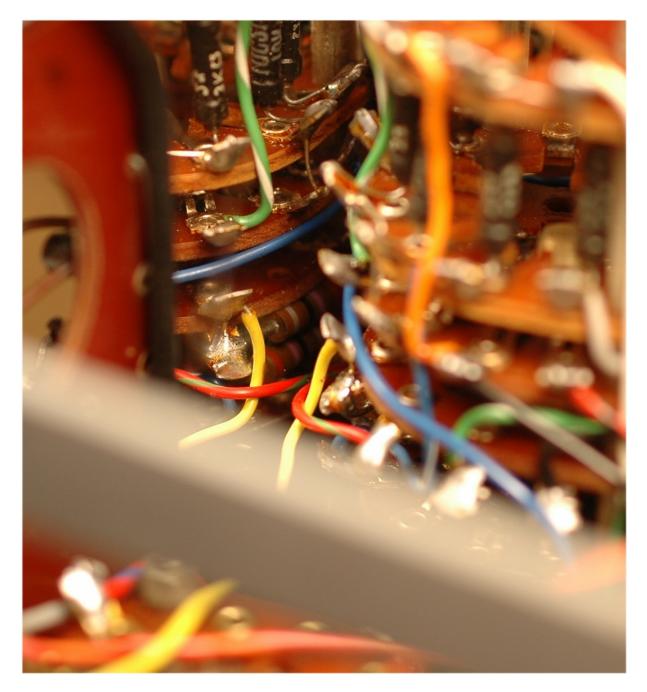
Photo 1: R37 (R37A & R37B) can be seen in the centre of the picture as two 27 Ω resistors in parallel, close to the two yellow wires

From the measurements it can be seen that AVO used two different sets of resistors for the relay shunt that was introduced in the CT160A, consisting of the pair of resistors numbered R37 (R37A & R37B). The same design was also used in the later AVO Mk IV and VCM163 to shunt the relay on the 120mA and 180mA ranges. In one of the CT160A's AVO used two resistors with a total resistance of 6.5Ω , this has been reported on earlier, but in the second CT160A AVO used two 27 Ω resistors making a total resistance of 13.5 Ω . The total resistance of 6.5 Ω means that CT160A works identically to the AVO Mk IV in the way the relay is shunted, only 56% of the current flows through the relay. In the second CT160A where the total resistance of the shunt is 13.5 Ω , the current flows through the relay is 73%, thus tripping the over current relay earlier as more current flows through the relay coil. The colour bands, denoting the resistor values, could only been seen clearly in the second CT160A, but the total resistance was measured in both.

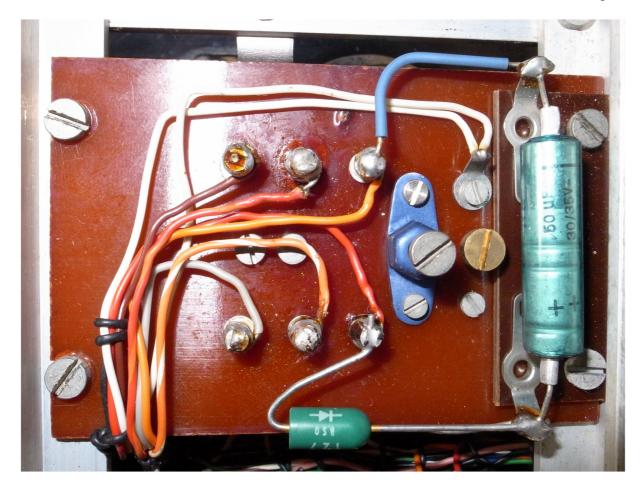
Photo 2: Diode D5, BY127, and capacitor C4, 50µF 30/35V, across relay coil in the AC mains circuit

Modifications have also been made to the coil in the AC mains circuit of the over current relay, with the introduction of a silicon diode and an electrolytic capacitor across this relay winding. These components act as a holding circuit, preventing some of the "chattering" that this relay experiences when the current is close to tripping the relay, and it also delays the release of the relay by a small amount when power is cut to the tester after the relay has operated. This modification was observed in both CT160A's. The value of the capacitor used is 50μ F with a voltage rating of only 35V, this capacitor had leaked in both of the testers and was replaced with a capacitor of higher voltage rating. The diode used was BY127 (Vrrm: 1250V, If: 1A)

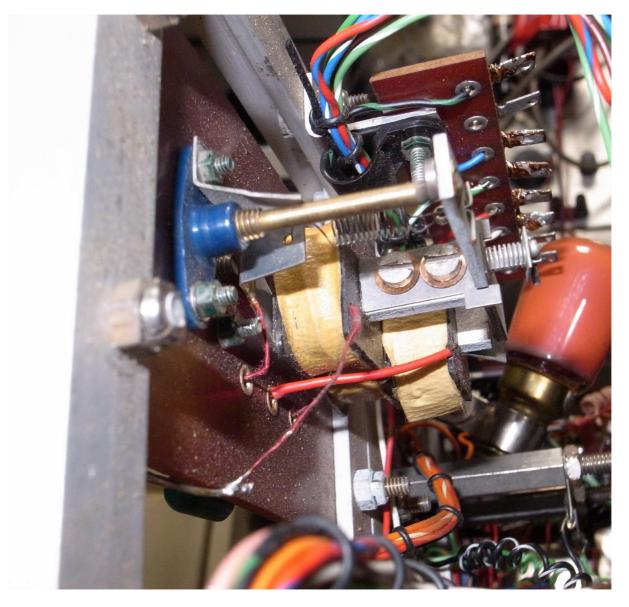
Photo 3: Modification to the relay coil in the AC mains circuit from behind, winding going to the point between diode and capacitor, to the cathode side of the diode D5

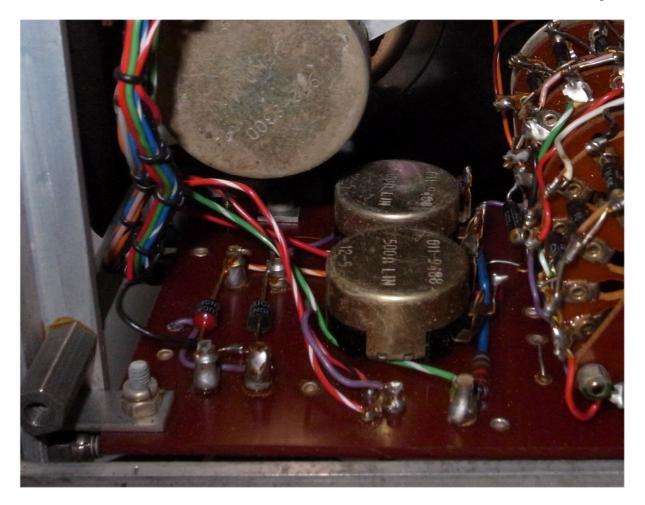
Photo 4: Diodes D2 & D3 (Lucas DD0058 was found in one CT160A, shown above and BY127 was found in the other CT160A) at the back of the PCB with Vg x 1 & Vg x 2 (RV3 & RV5) potentiometers and R4

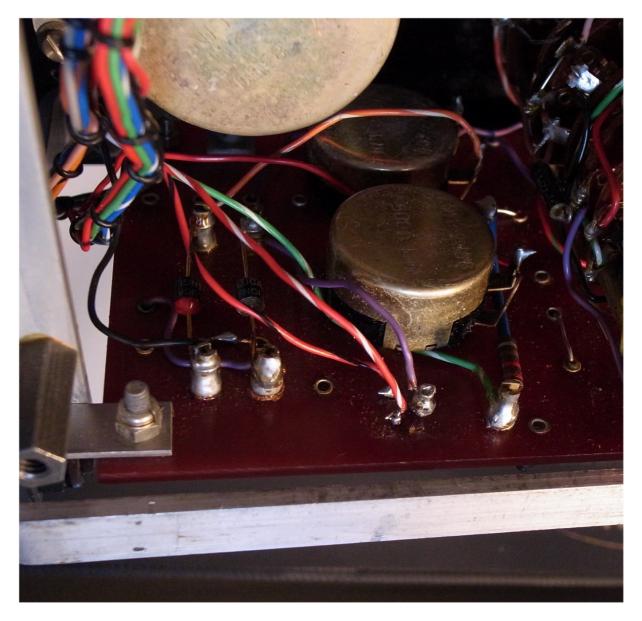
Photo 5: Different angle of components at the back of the PCB

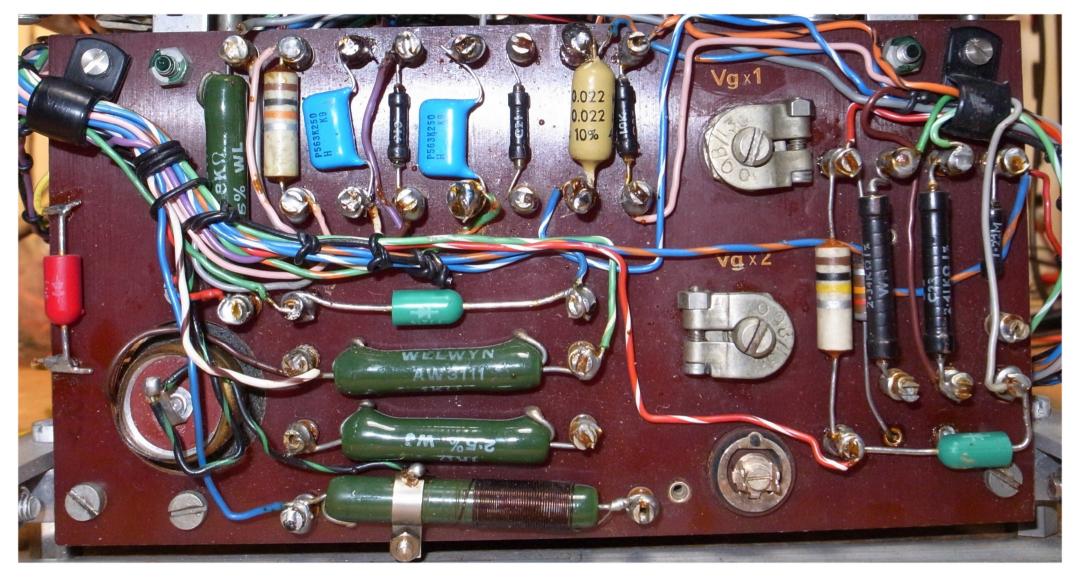
Photo 6: Front of PCB with components found in CT160A, to the far left RED diode D6 in Anode & D/R circuit, to the far right GREEN diode D1 in screen circuit, in the center GREEN diode D4 in "backing-off" Anode Current circuit. Resistor R41 at $82k\Omega$ can be seen close to R38 at $100k\Omega$ near the Vg x 2 potentiometer. RV6 is right below the Vg x 2 potentiometer.

Another modification observed was that a silicon diode (BY127) had been inserted into the Anode circuit of the tester, just after the switch SH1, before the over current relay; thus using half wave rectification for both normal valve testing and rectifier/diode testing. No resistor to ground could be seen, and the circuit can be improved by adding this; otherwise you will not get a correct reading with a high impedance meter when measuring the voltage on the anode or diode connections, owing to the build up of charge, which makes correct measurements impossible; just as my friend Euan MacKenzie found and also tested in his AVO CT160; which he modified in a similar way (a Silicon diode and a $100k\Omega$ resistor were inserted after the Anode selector switch before SH1).

However, in my opinion the most important finding was that the wiring of the components in the calibration resistor path was found to differ substantially from the earlier AVO schematic, which was the only schematic known to exist at the time. In the earlier schematic, the components RV6, R41, D2 and R3 (the $1.22M\Omega$ "calibration resistor") were not drawn correctly either. A modification was assumed by me, since the connection drawn in the schematic diagram would not work; as the voltage from the 66V winding drawn in the schematic was insufficient. This could easily be checked if you calculated the voltages needed for the circuit to work. The schematic showed that the circuit was powered from the 66V winding; calculations showed that it would need power from the 99V winding to work correctly. However the latest CT160A showed a totally different wiring; the wiring was traced by Mr. Yutaka Matsuzaka to check how it all was connected. I could see that

something was not correct in the photos when I compared them with the schematic drawings, which led me to ask Mr. Yutaka Matsuzaka to check the wiring. In both of the CT160A's the potentiometer RV6 has one side connected to the 82.5V winding and the other side to the 110V winding, and the potentiometer wiper connected to the cathode of D2, the anode of D2 was connected to R3 & R41. The other side of R41 was connected to ground and the other side of R3 was connected to switch SG5 pin 1-6; which is used for the calibration voltage and leakage/isolation tests. This is a smart design change as it will make it possible to calibrate the tester over a wider voltage span than with the calibration circuit just connected to one voltage tap. This method of connecting RV6 was made in the original factory wiring; and was not something that had been changed later; this could be seen from the way the wires had been soldered, they had not been resoldered or altered in any way. The voltage levels used in the above description are RMS voltages; this means that the 66V winding corresponds to 60V Mean DC, the 82.5V corresponds to 75V Mean DC, the 99V corresponds to 90V Mean DC and the 110V corresponds to 100V Mean DC, where the Mean DC voltage is the voltage that is printed on the front of the tester, and also on the labels on the transformer.

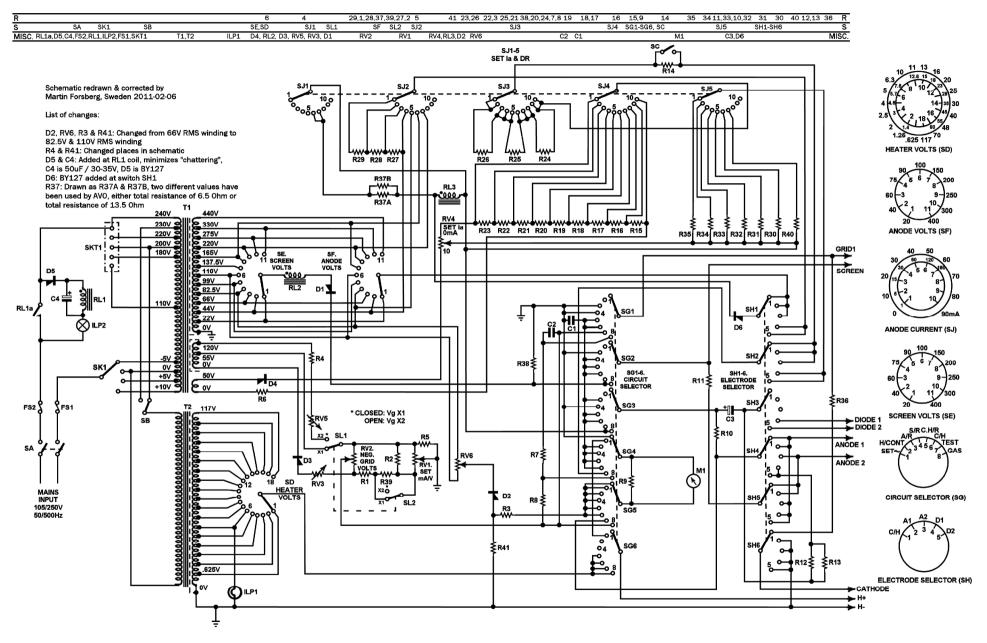
You can see these corrections in the schematic, now that it has been corrected by comparisons with two actual CT160A Valve Testers. You can also see the modifications made to the relay circuit, the two extra resistors used to decrease the relay sensitivity, and the extra diode in the Anode circuit, in the photos provided.
